CHATELAILLON (FRANCE)

1. GENERAL DESCRIPTION OF THE AREA

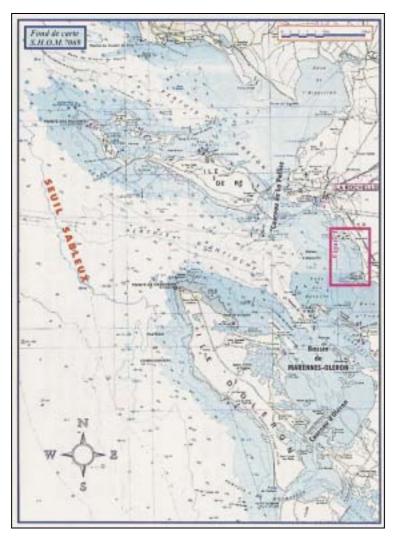
Fig. 1: Map of the study site in the "Pertuis d'Antioche"

The bay of Châtelaillon is open on the "Pertuis d'Antioche", a little sea located between the northern Ré Island, the southern Oleron Island, and French coast in the east. The bay of Châtelaillon is enclosed by the headland of Chay (north) and by the submersible rocks of the Châtelaillon's headland (south). The beach studied in this case is 2400 meters long. A seawall is built on the upper beach, and protects the city of Châtelaillon against flooding.

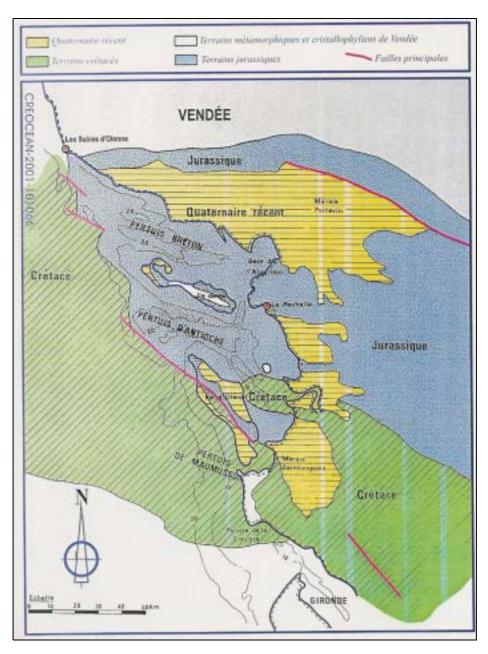
Fig. 2: Geologic map of the area

The bay is part of the Aquitaine basin with secondary layers from the Jurassic with limestone and marl materials. The littoral has evolved during the quaternary and influenced by sea level variations. The marshlands were filled up with fine sand and mud. The beach sand has a D50 between $200\mu m < D50 < 260\mu m$ (fine sands)

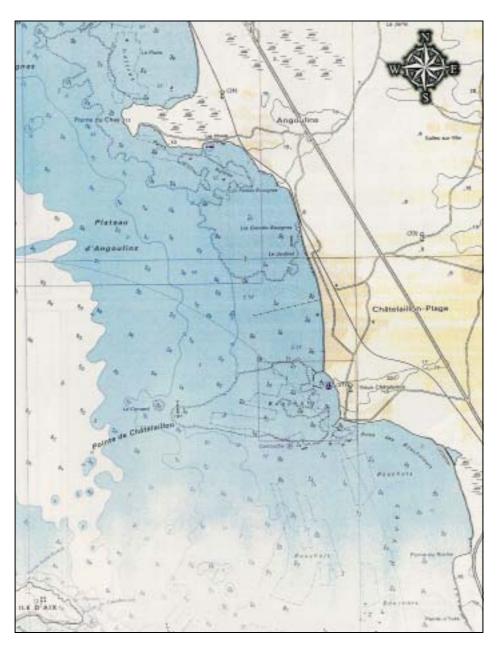
Fig. 3: Bathymetric map of the studied beach in Châtelaillon.

The bottom of the bay of Châtelaillon in the "Pertuis d'Antioche" has a low angled slope (level –5 meters at 4,5 Km from the foreshore). The bay could be separated in three components:

- > The sandy foreshore close to the seawall
- The rocky shore (lower foreshore)
- > The rocky and sandy submarine shore changes into muddy bottom

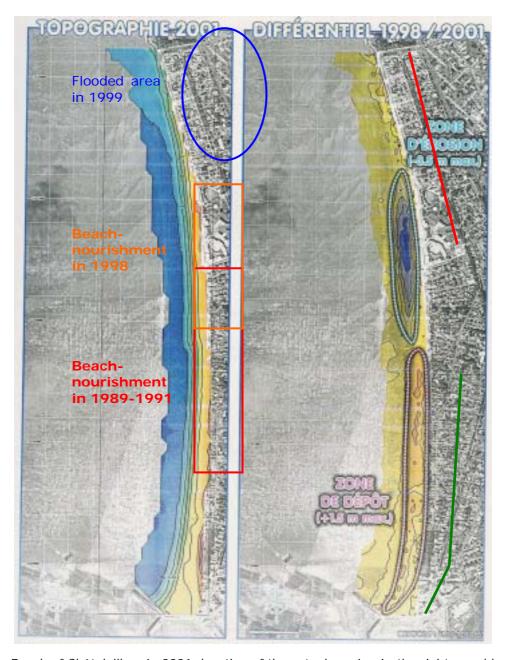
Fig. 4: Beach of Châtelaillon, in 2001, location of the actual erosion In the right map blue colors indicate erosion and red colors sedimentation.

At the moment, after the two beach nourishments, actual erosion is mainly located in the north, which is never been nourished. The erosion results in a low and narrow foreshore, with a low angled slope (around 3%). The longshore current due to waves, wind and current transports the sand from north to south. Here the beach is high with embryonic duneforms and wide.

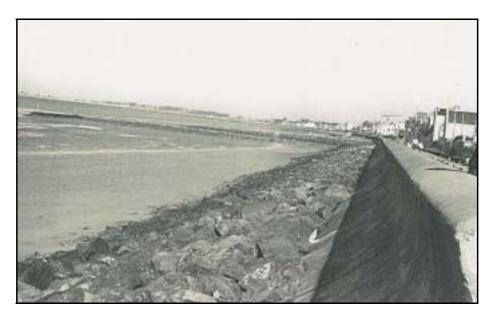
Fig. 5: The beach prior to the beach-nourishment (1988). The foreshore is narrow, the groins and the rocks on the foot of the seawall are not efficient measures against erosion.

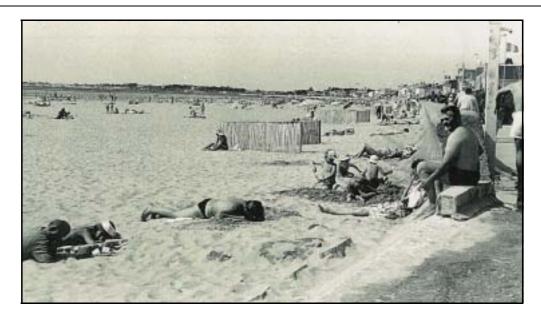
Fig.6: After the beach-nourishment (1992), the top level of the beach has been elevated with about 3,5 m. The potential for tourism and the protection against flooding are improved.

In the first operation, carried out in three years (1989-1990-1991), 330.000 cubic meters of marine sand, from the Chassiron sand bank (north of Oleron island) was used. The aim of the nourishment was to cover the rocks on the foot of the seawall and to elevate the top of the beach with 3.5 meters (from 4.5 m CM to 8.0 m CM) The width of the beach was increased from 15 meters to 100 meters. The costs were about 15 millions of francs in 1991. Subsidies were fromthe FEDER, the department of "Charente maritime" and the SIVOM of La Rochelle (association of the cities).
