## SITGES (SPAIN)

## 1. GENERAL DESCRIPTION OF THE AREA

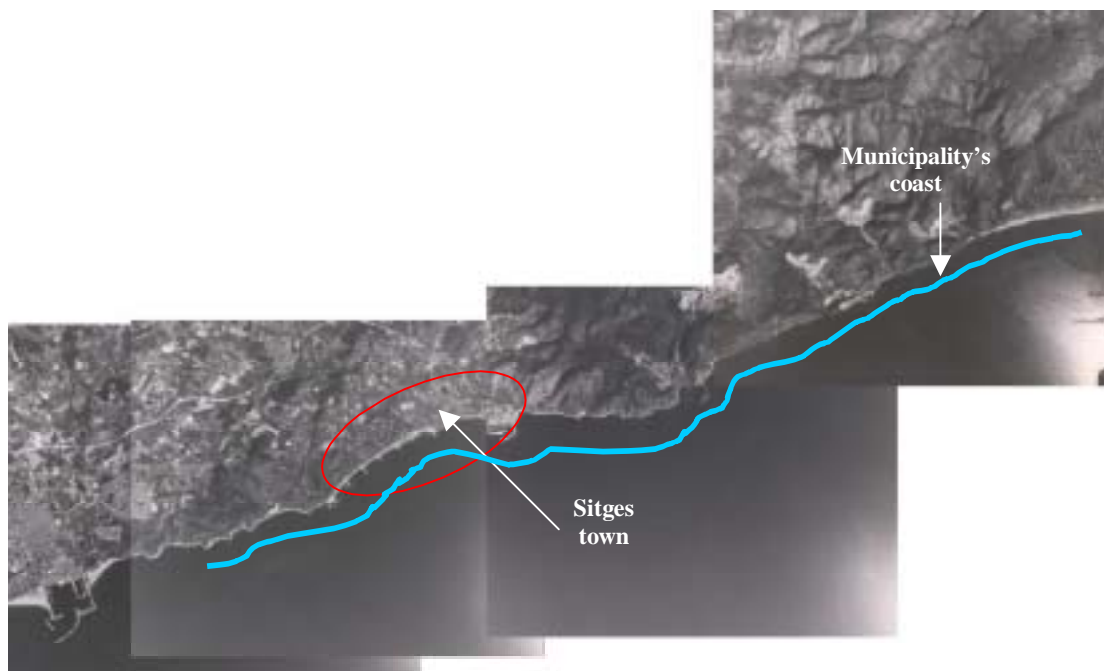
*Fig. 1: Aerial photograph's composition of Sitges coast.*

The town of **Sitges** is located at the Mediterranean coast in Catalonia, an autonomous region in the northeast Spain, 40km south of Barcelona. Sitges has a coastal stretch of approximately 19km, which is made up of rocky coast and sandy beaches. There are 18 beaches in the municipality's coastal area, of which 10 are in front of the urban area. The study area is located at the urbanised coastal area (see Figure 1).

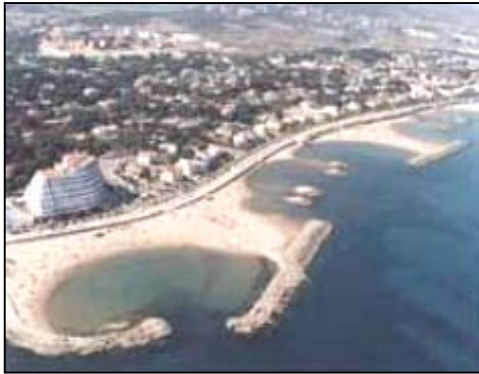
*Fig. 7: Groynes (n°1)*

The numerous groynes retain the sediments that circulate in a NE-SW longshore drift and avoid the feeding of the western beaches (Estanyol, Riera Xica, Barra, Terramar and Anguines), worsening the problem of erosion in these areas.

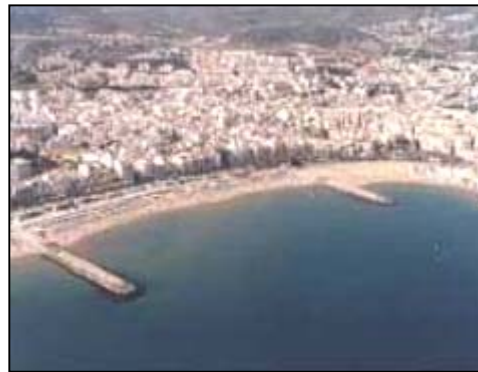
*Fig. 8: Detached breakwaters (n°2)*

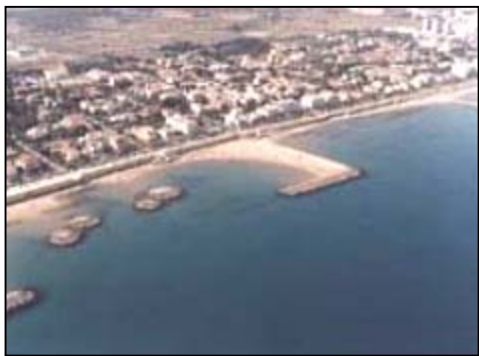
*Fig. 9: Artificial islands & t-shaped breakwater (n°3-4)*

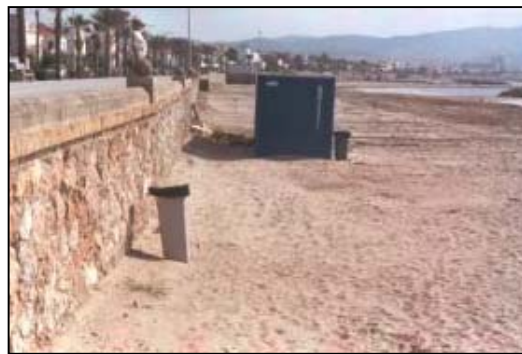
*Fig. 10: Seawall (n°5)*

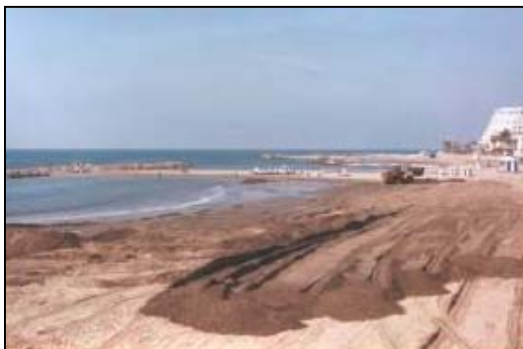
*Fig. 11: Sand replenishment (n°6)*

Beach nourishments of 1984 consisted on 34,700m<sup>3</sup> of sand dredged from Vilanova i la Geltrú, southwest of Sitges town. The last performance of nourishment has been done in July 2002 in Estanyol, Riera Xica, Barra and Terramar beaches, and consisted of a sand filling of about 50,000m<sup>3</sup> dredged from Port Ginesta marina and cost about 480,000€.

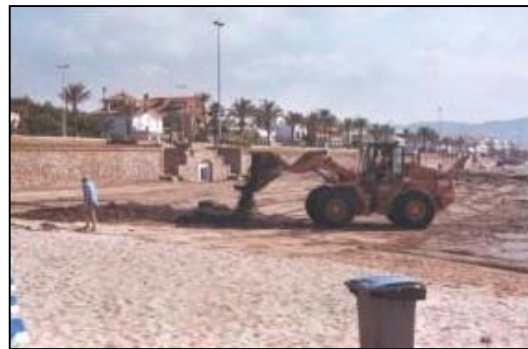
*Fig. 12: Sand replenishment works (n°6)*

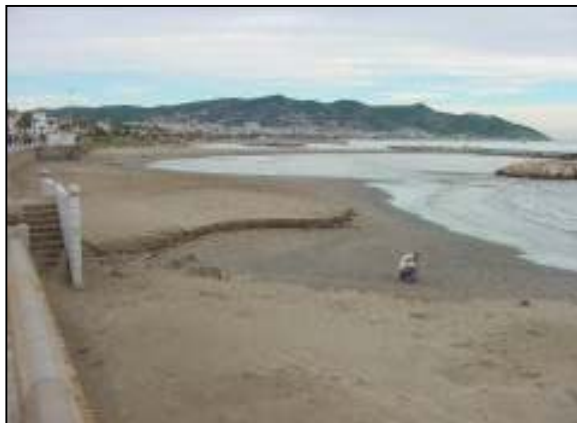
*Fig. 13: Effects of the September 2002 storms in Barra beach. The scars were made by the river discharge. This beach was renourished in July 2002.*

After the last beach nourishment operation in July 2002, a set of storms swept away a huge part of the freshly nourished sediments. (see Figure 13).
